Memorandum

*Subject: Summary of Oversight of Equipment Servicing
July 16–17, 2019
Lower Passaic River Restoration Project*

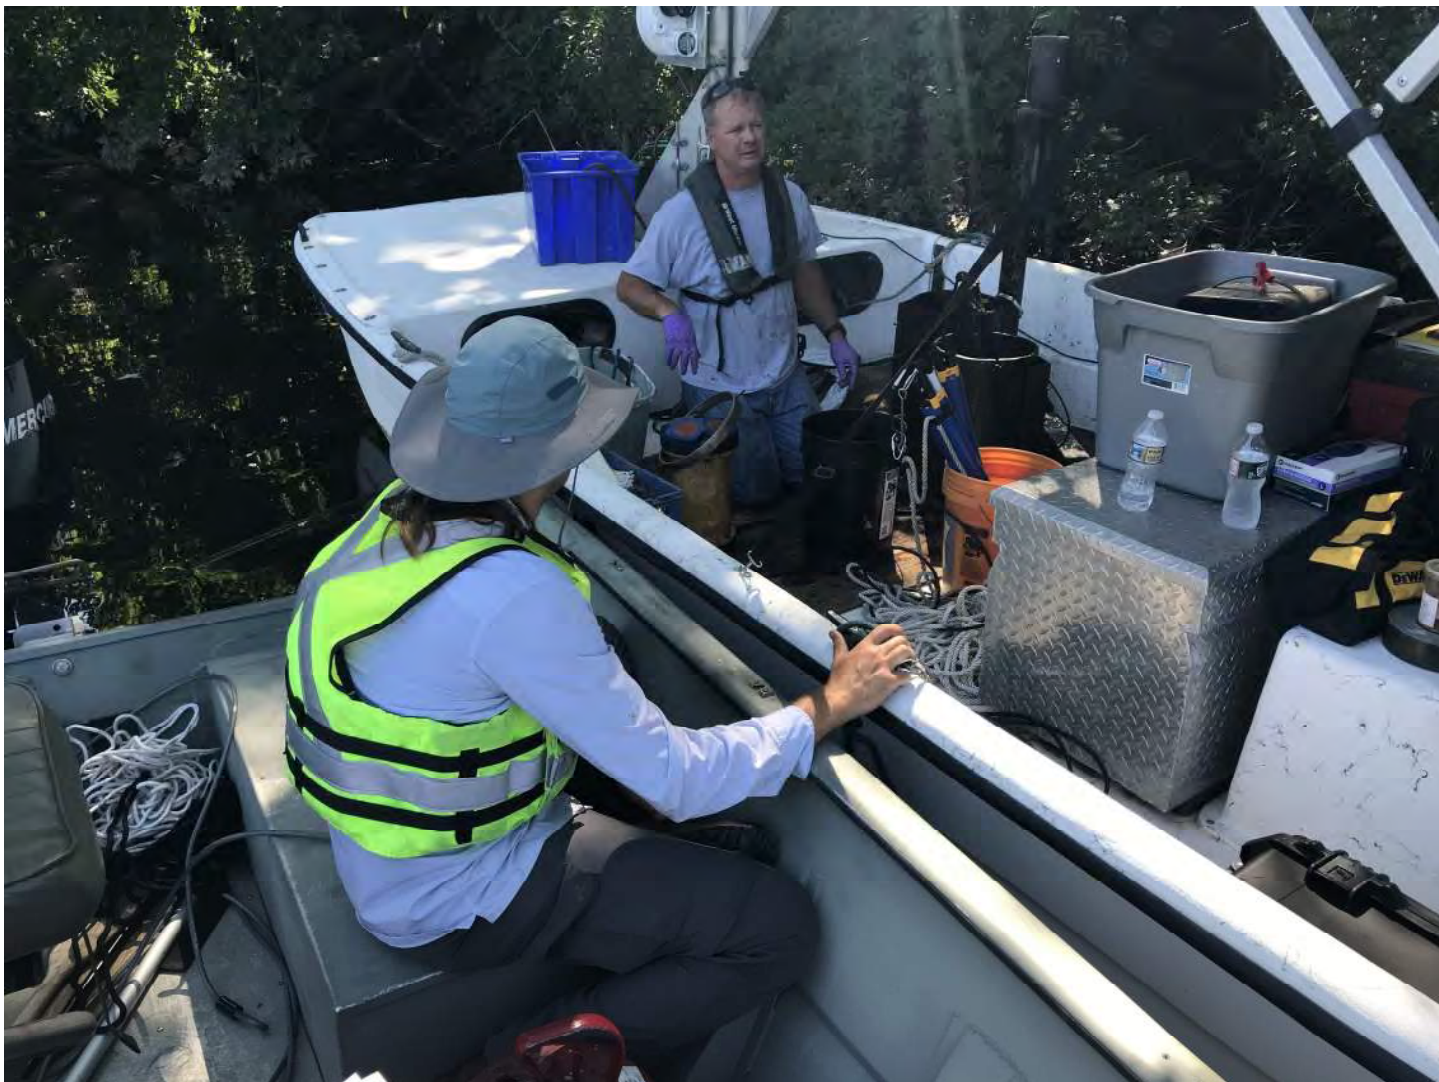
Photograph 8: RM 13.5 bottom ADCP removed and cleaned and bottom YSI compared against boat YSI.

1020 ^{ADCP} ~~ADCP~~ collecting voltage reading from ADCP to confirm battery is OK
 started @ 42 v when deployed.

At 41 v today.

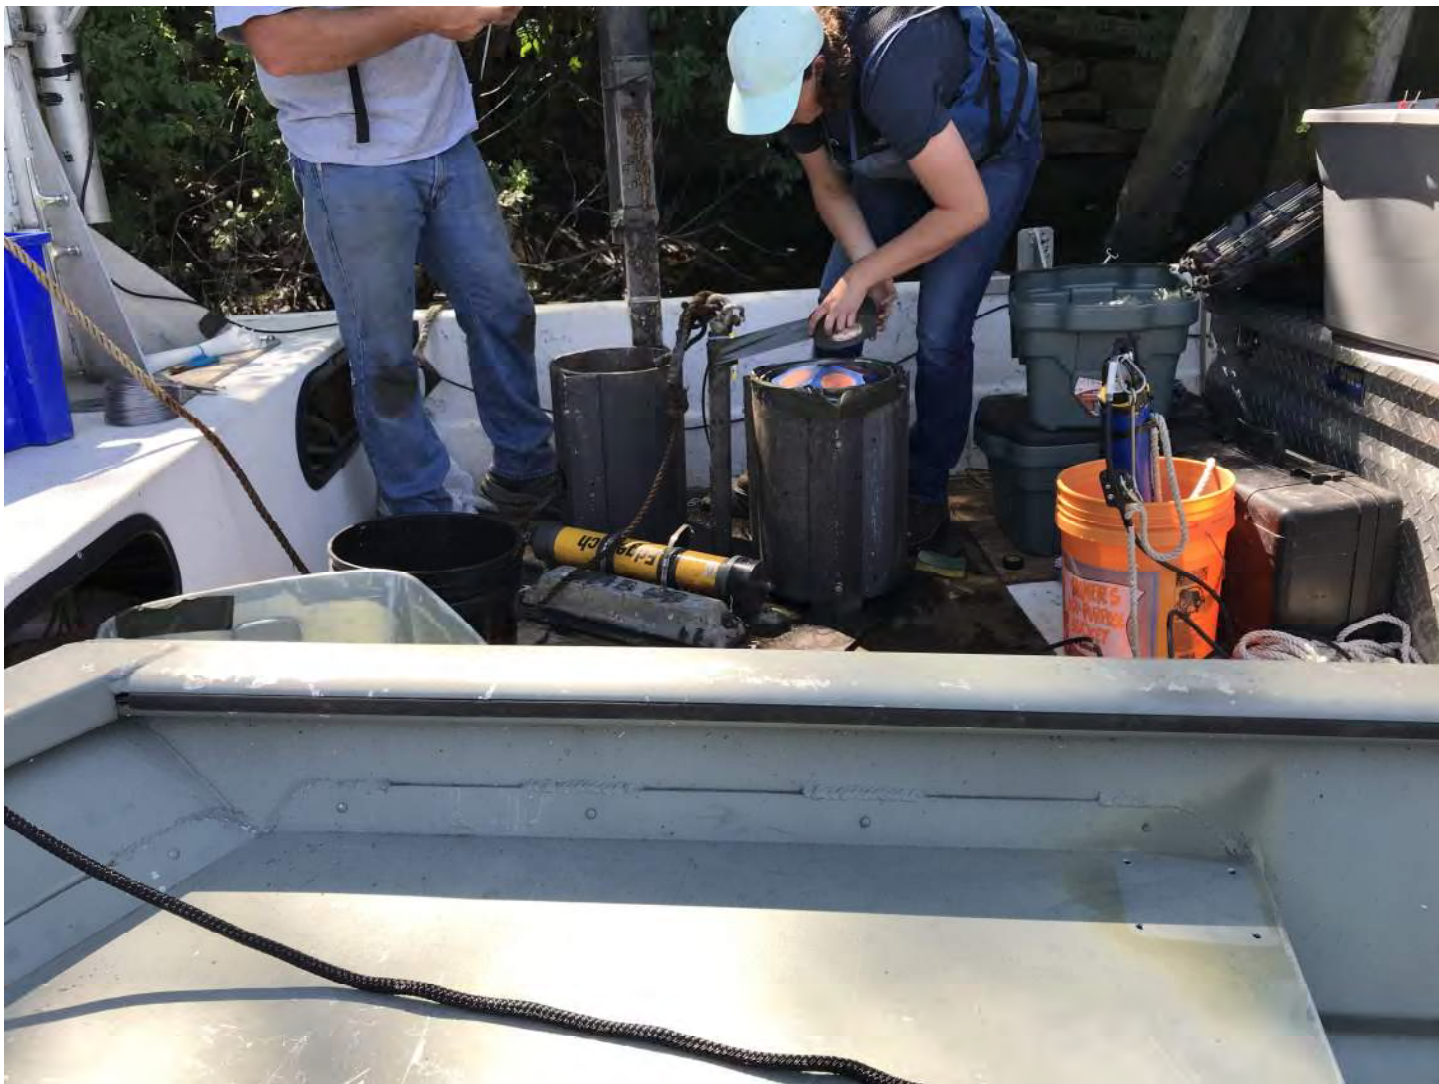
Photograph 9: Backup locator beacon attached to RM 13.5 mooring.

1045 Redeploying YSI + ^{ADCP} ~~ADCP~~ with a locator pin attached to mooring (as a backup)

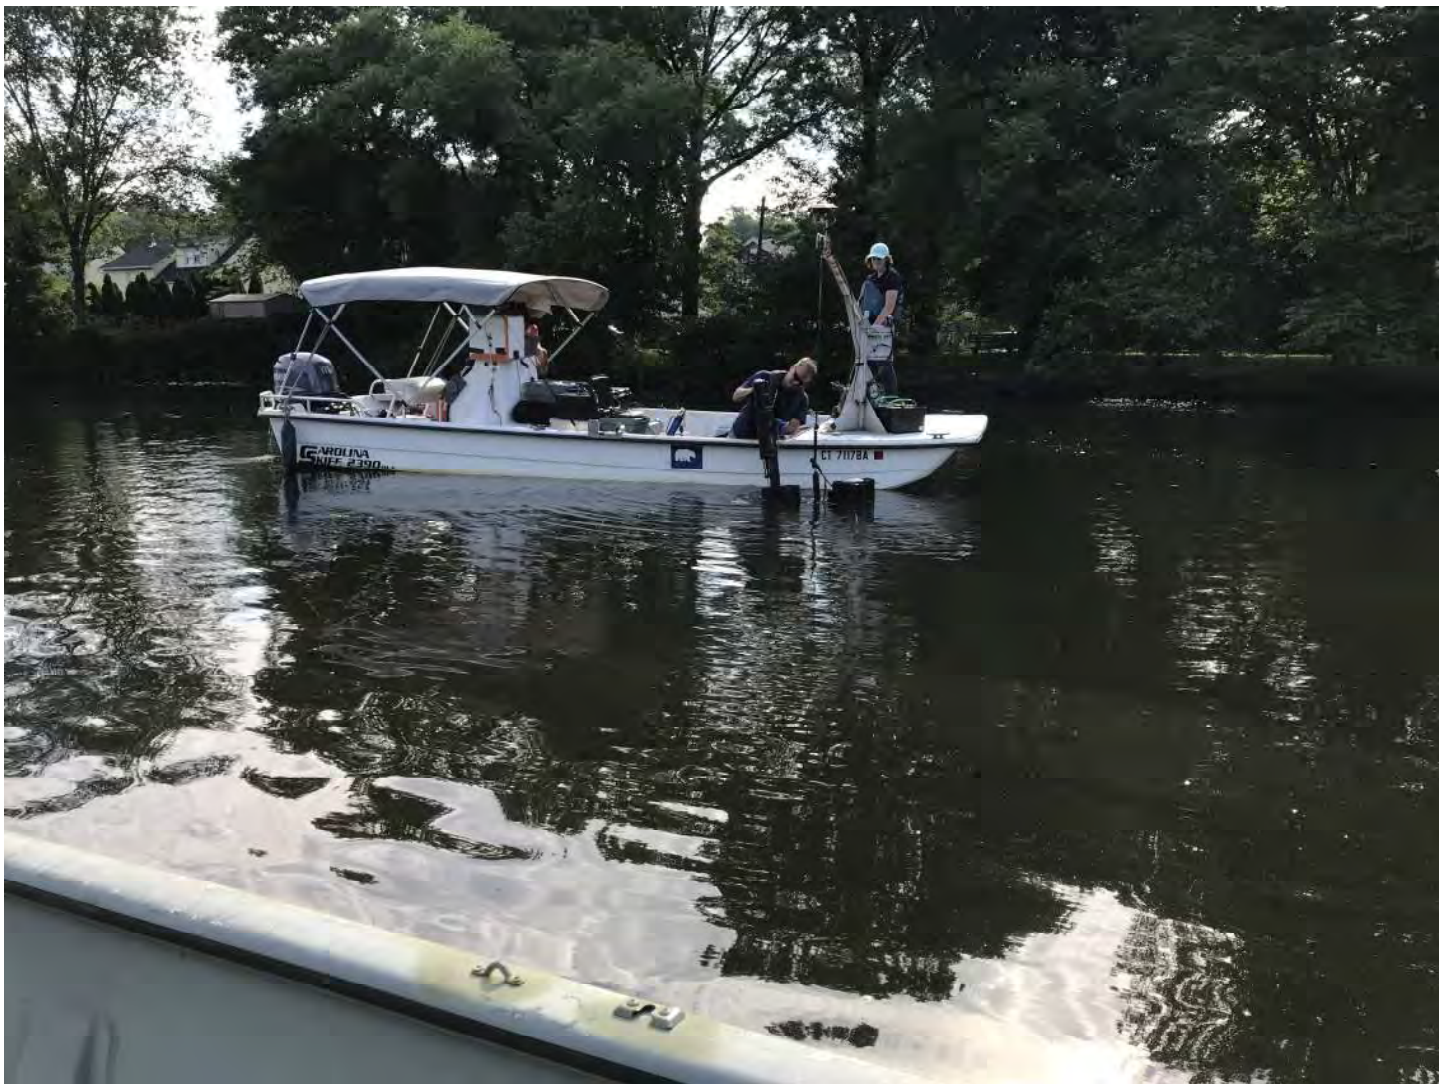
Photograph 22: RM 12.0 bottom mooring retrieved and cleaned.

ADCP tested functional. Packing locator being attached to mooring. Comparing bottom YSI + boat YSI. The comparison was good w/ the boat YSI, but a ~~pre~~ ^{APW} preliminary check of the data seemed to have

(50,00,90 ntu) abnormally high turbidity, so the sande will be replaced (after comparison w/ the boat sande to make sure the replacement sande is collecting comparable data). Comparability between boat sande and replacement sande is good, so the replacement sande will be deployed at the bottom RM 12.0 mooring. Drilling a new mooring hole in the mooring so the YSI sensors can be exposed (the replacement sande is shorter than the one that was originally deployed). Replacement sande wiper didn't initiate as scheduled, so a different replacement is being checked.

1050 Ended up ^{replacing +} recalibrating the turbidity sensor on the original sande. Check against the boat sande was good (again), so the sande will be redeployed.

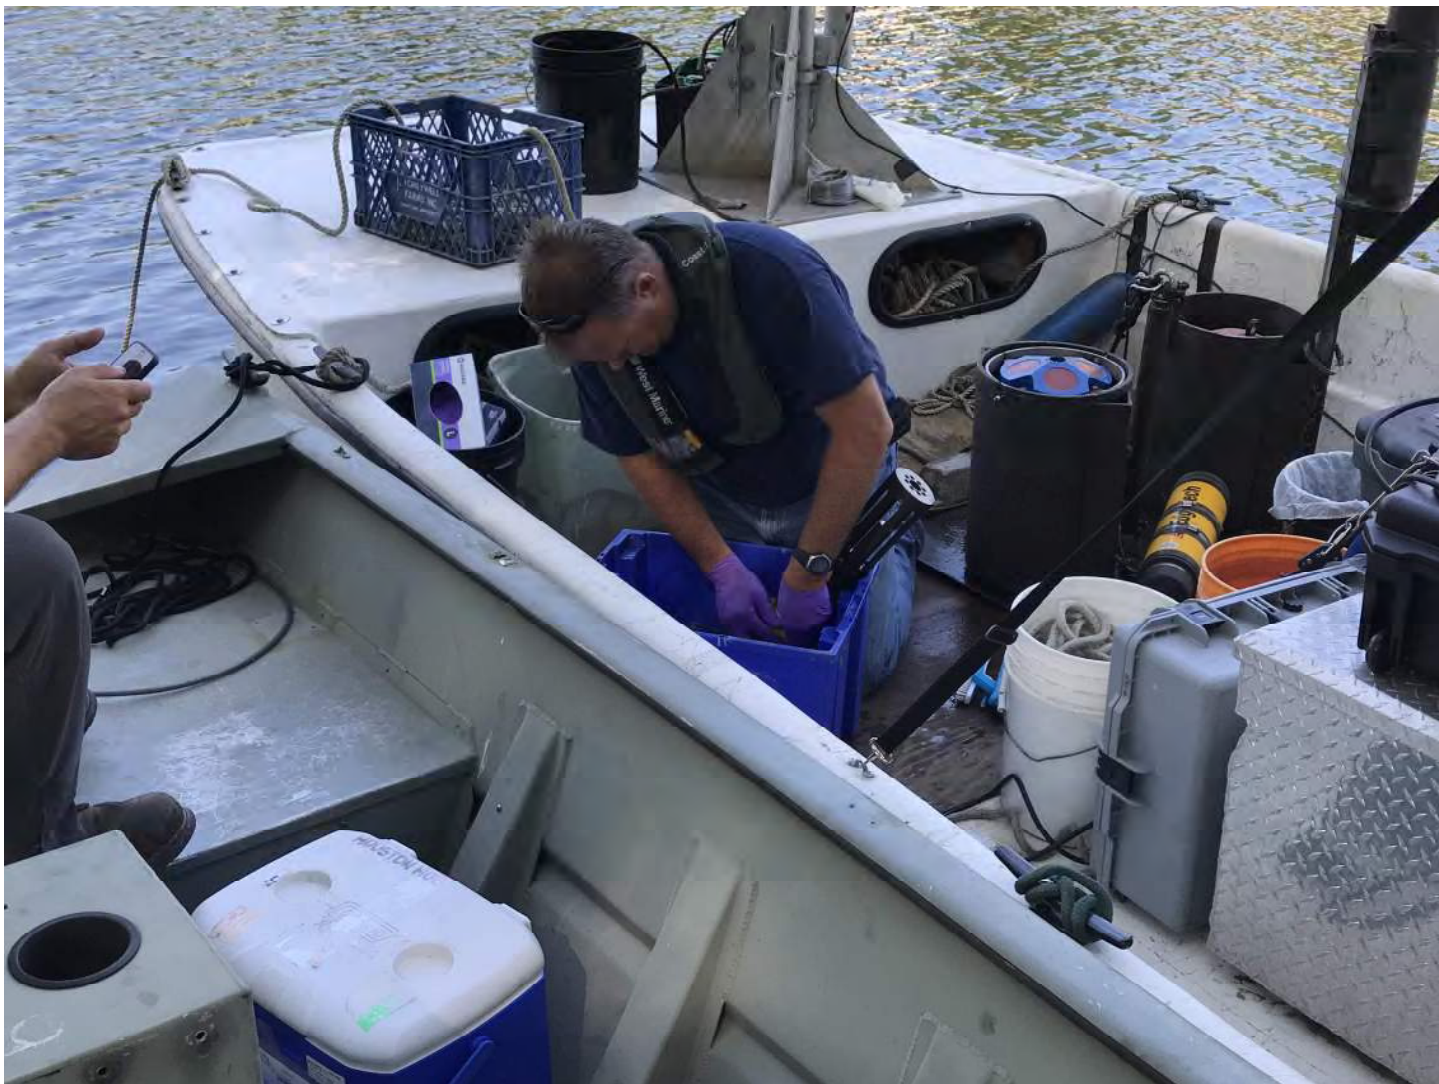
The RM 12.0 bottom mooring locator buoy was released and the mooring was retrieved. The bottom-mounted YSI was removed and cleaned, had its data downloaded, had its wiper confirmed functional, and was compared against the calibrated boat YSI. During preliminary review of the data stored by the bottom-mounted YSI, the turbidity appeared abnormally elevated (around 60 nephelometric turbidity units). Even though the YSI comparison with the calibrated boat YSI was good during the servicing event, the turbidity sensor of the bottom-mounted YSI was removed, replaced, recalibrated, and compared again against the boat YSI (the comparison was good). The ADCP was removed, cleaned, had its data downloaded, and its four sensors were confirmed to be functional. Both the ADCP and YSI were remounted, the locator buoy was reset, and a backup locator beacon was attached to the mooring. The

Photograph 24: RM 12.0 bottom YSI removed and cleaned.

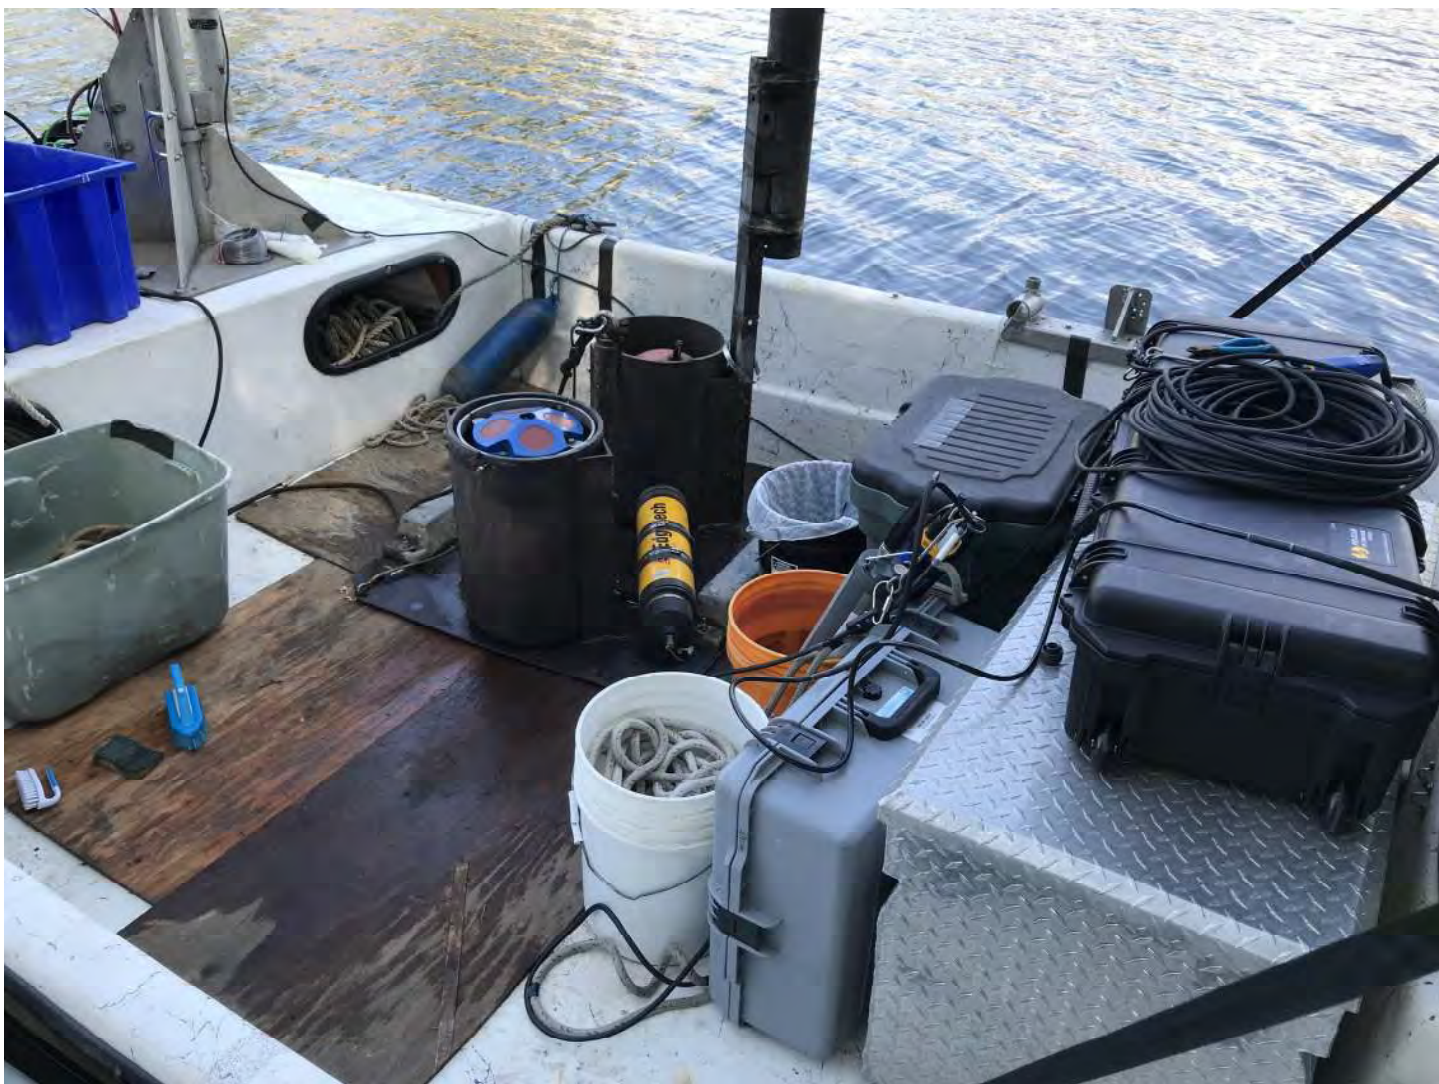
Photograph 25: RM 12.0 bottom YSI compared against boat YSI.
